# FIRE RISK ASSESSMENT

HMO & Residential Premises · Example of what JHS customers receive

| Premises address | 14 Sample Terrace, Exampleton EX0 0AA |
| Reference | JHS-FRA-SAMPLE-001 |

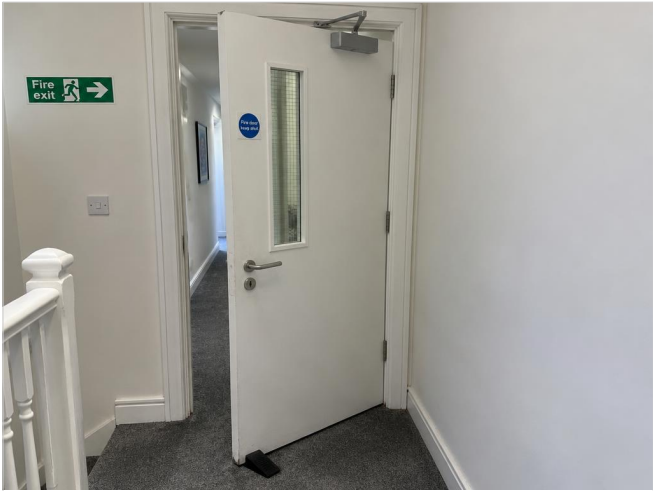
| Ref | Consideration | Y / N | Rating | Assessor notes |
|---|---|---|---|---|
| FDR1 | Fire doors self-closing, close fully and are not wedged open? | N | RED | First-floor landing door wedged open with a rubber wedge (photo P01). Action A1. |

RED

**P01** · First-floor fire door wedged open (FDR1 → A1)

| Ref | Action required | Priority | Timescale | Who | Done (date / by) |
|---|---|---|---|---|---|
| A1 | Remove the door wedge and keep the first-floor fire door closed. Clear the bicycle and boxes from the hallway and provide alternative storage. Remind tenants in writing. | A | Within 7 days | Landlord | |

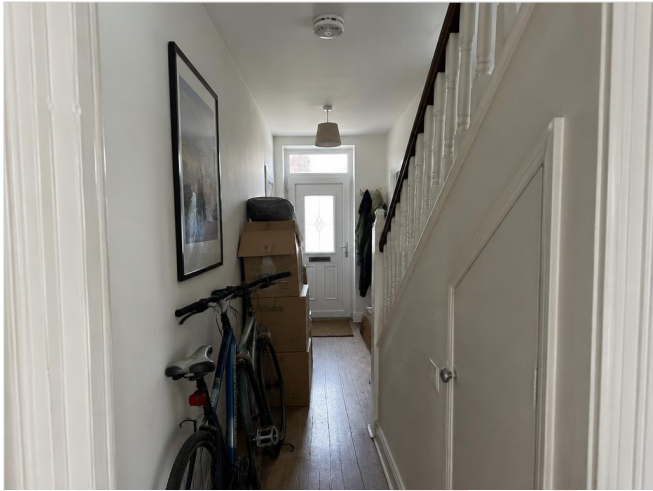
| Ref | Consideration | Y / N | Rating | Assessor notes |
|---|---|---|---|---|
| IG4 | E-bikes / e-scooters not stored or charged in the escape route? | N | AMBER | Bicycle (non-electric) stored in hallway (photo P02). Confirm no e-bikes are kept inside. Action A1. |

| Ref | Consideration | Y / N | Rating | Assessor notes |
|---|---|---|---|---|
| ME1 | Escape routes kept clear of obstructions and stored items? | N | RED | Bicycle and boxes partly blocking ground-floor hallway (photo P02). Action A1. |

RED

**P02** · Bicycle and boxes in ground-floor escape route (ME1 → A1)

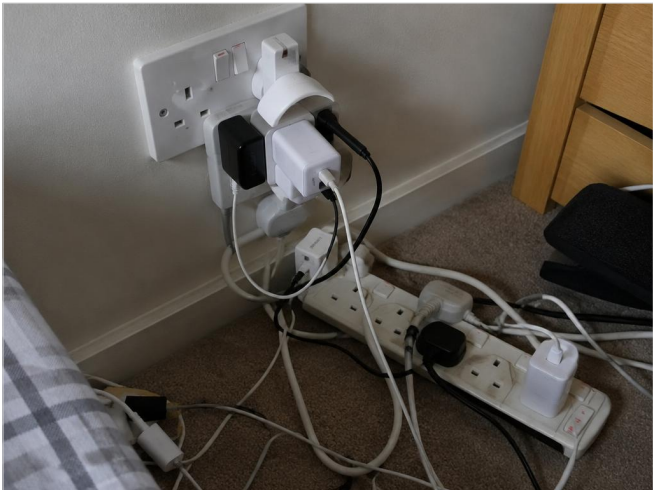
| Ref | Consideration | Y / N | Rating | Assessor notes |
|---|---|---|---|---|
| IG2 | Sockets not overloaded; no daisy-chained extension leads? | N | RED | Room 3: two extension leads plugged into each other with several adaptors (photo P03). Action A2. |

RED

**P03** · Daisy-chained extension leads, Room 3 (IG2 → A2)

| Ref | Action required | Priority | Timescale | Who | Done (date / by) |
|---|---|---|---|---|---|
| A2 | Remove daisy-chained extension leads in Room 3. Advise the tenant on safe use and consider extra sockets installed by a competent electrician. | A | Within 7 days | Landlord | |

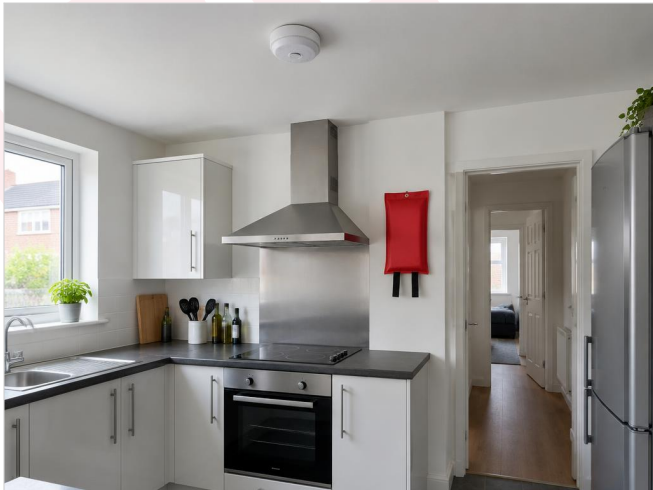
| Ref | Consideration | Y / N | Rating | Assessor notes |
|---|---|---|---|---|
| CX3 | Fire blanket provided in the kitchen? | Y | GREEN | Fire blanket wall-mounted beside the cooker (photo P04). |

GREEN

**P04** · Kitchen heat detector and fire blanket (CX3, satisfactory)
